FULL RESERVE STUDY

Autumn Lake Property Owners Association

Pearland, Texas
December 5, 2017

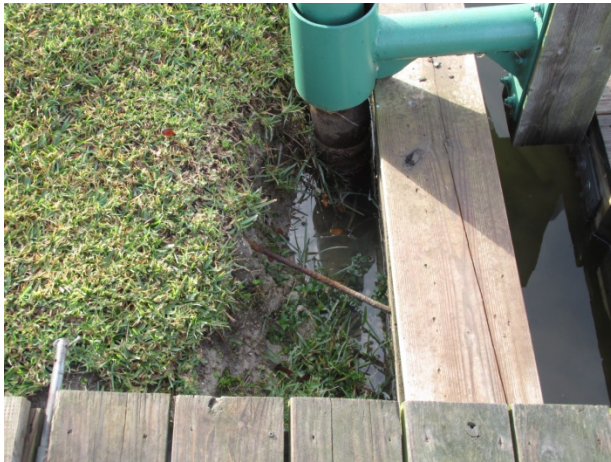
Conditions: Good to fair overall

Shoreline erosion by bulkhead

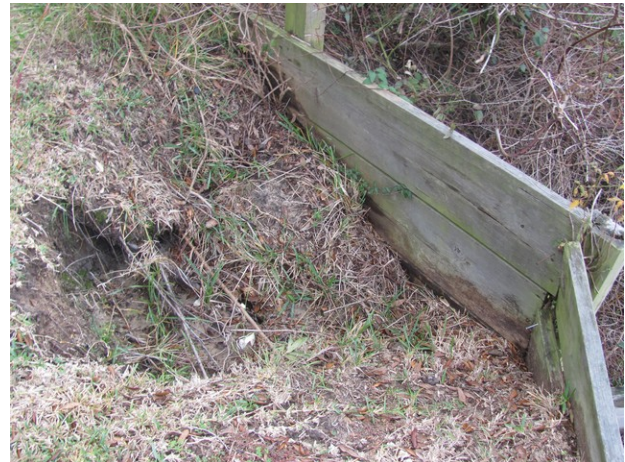
Erosion behind retaining wall

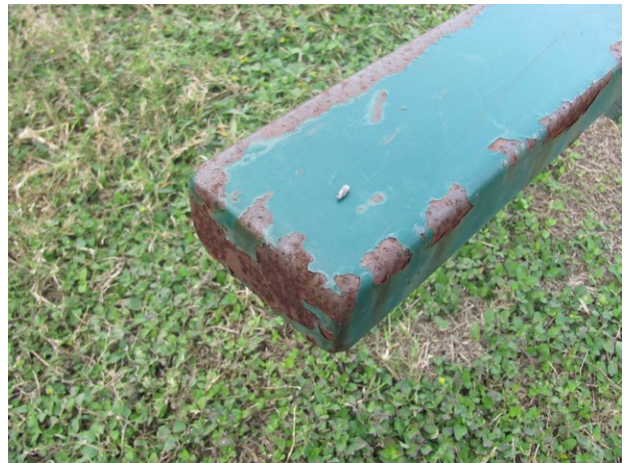
Condition: Good overall with isolated finish deterioration

Finish deterioration

Expenditure Detail Notes: Expenditure timing and costs are depicted in the **Reserve Expenditures** table in Section 3. We recommend the Association budget for interim repairs and paint finishes through the operating budget.

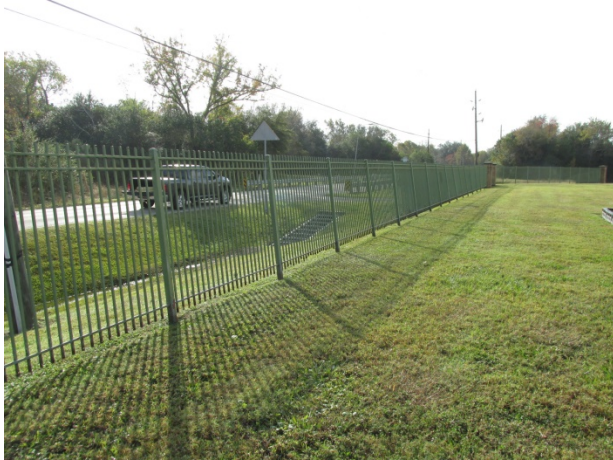
Condition: Fair overall condition with finish deterioration, rust and leaning sections evident.

Leaning section

Expenditure Detail Notes: Expenditure timing and costs are depicted in the **Reserve Expenditures** table in Section 3. Our cost is based on information provided by the Management. Management informs us the Association anticipates near term replacement. We recommend the Association plan to replace the steel fence in a phased manner beginning by 2018 and concluding by 2019.

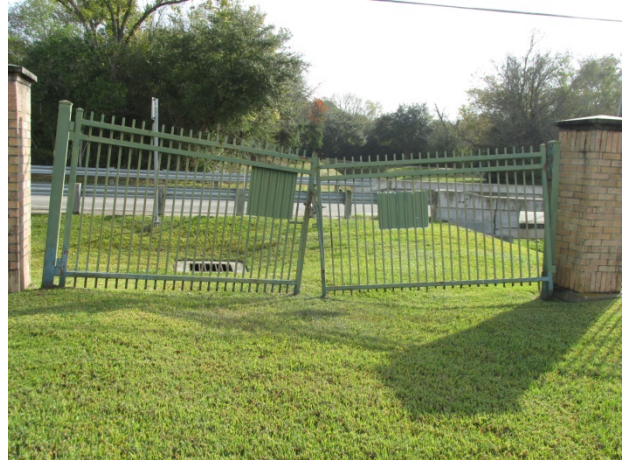
Leaning section

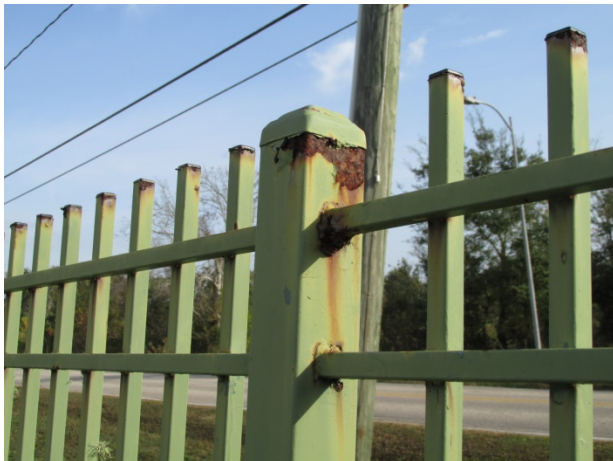
Finish deterioration and rust

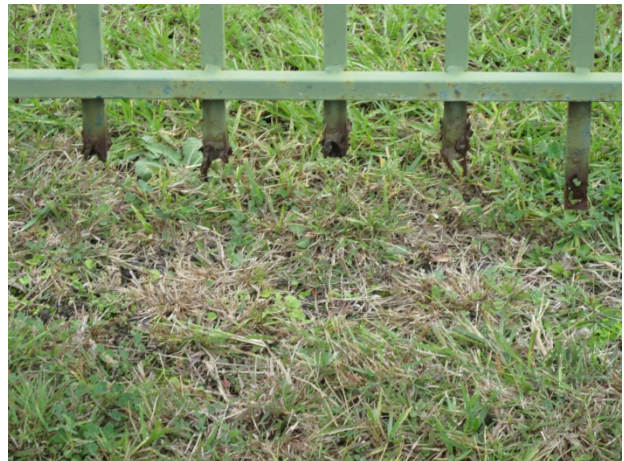
Rusted and deteriorated rails

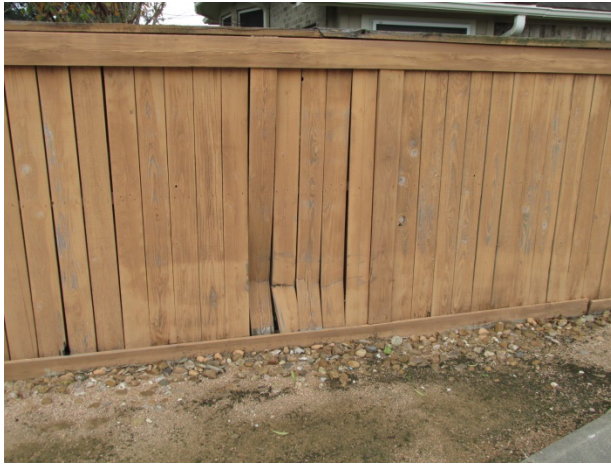
- The fence along Miller Ranch Road is in good overall condition with isolated wood rot and deterioration evident.
- The remaining fences are in good to fair overall condition with isolated damage, loose pickets, finish deterioration, deflection and missing pickets evident.

Damage

Expenditure Detail Notes: Expenditure timing and costs are depicted in the **Reserve Expenditures** table in Section 3. The Association should anticipate periodic partial replacements due to the non-uniform nature of wood deterioration.

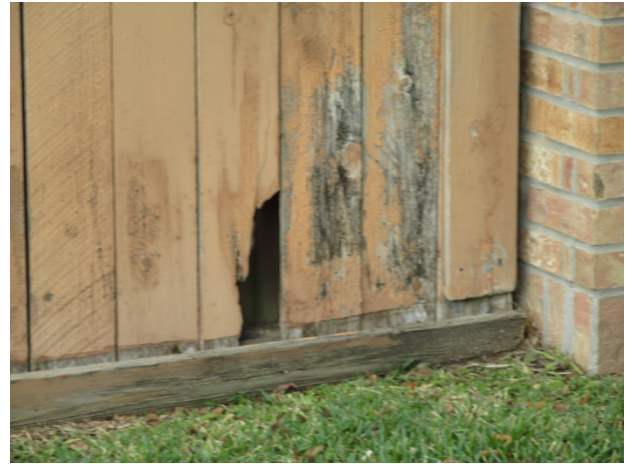
Finish deterioration and damage

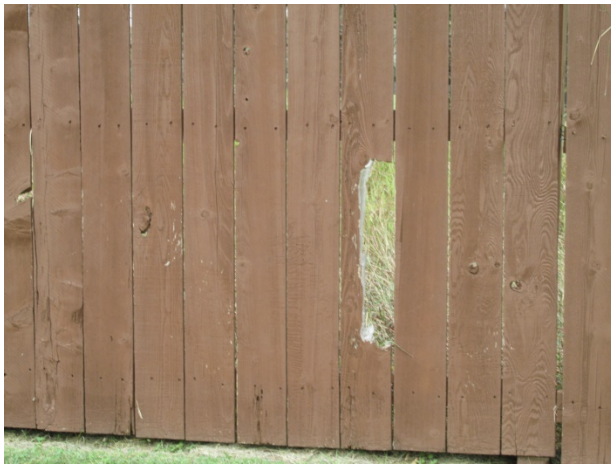
Damaged picket

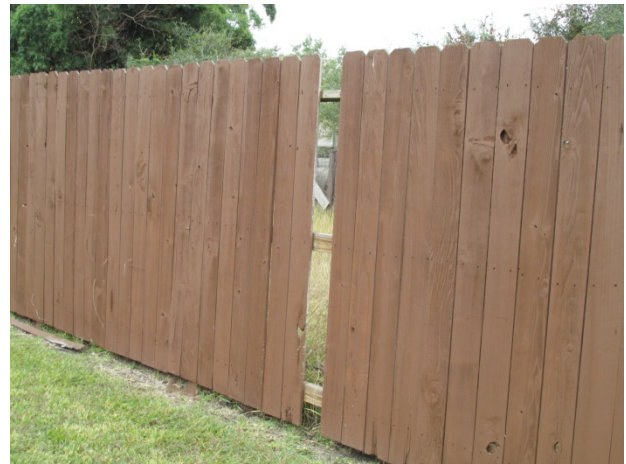
Missing picket

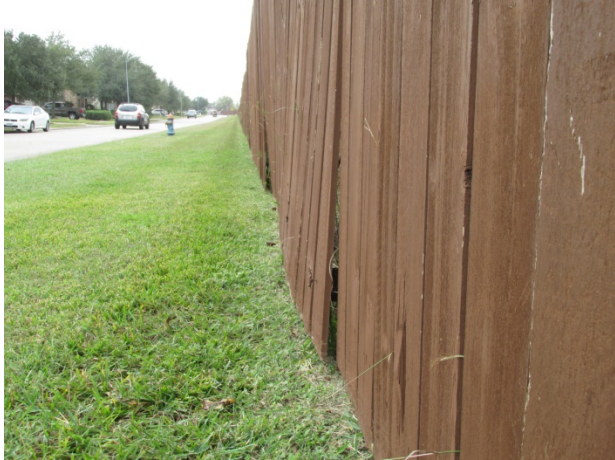
Loose and deflected pickets

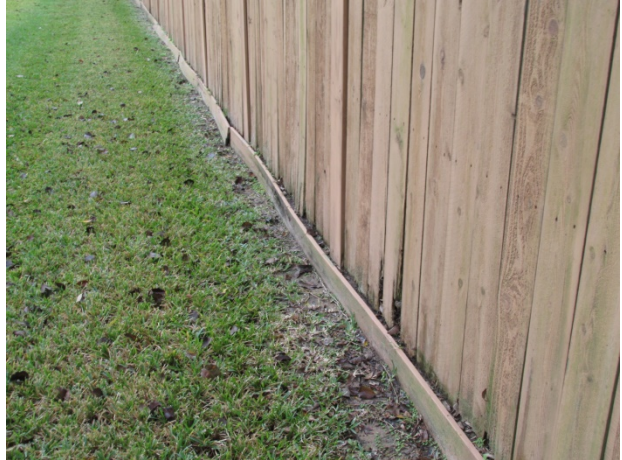
Pickets detached from base

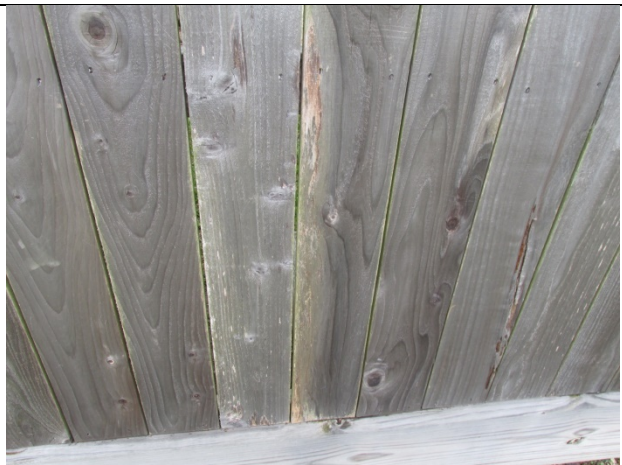
Wood deterioration at Miller Ranch Road

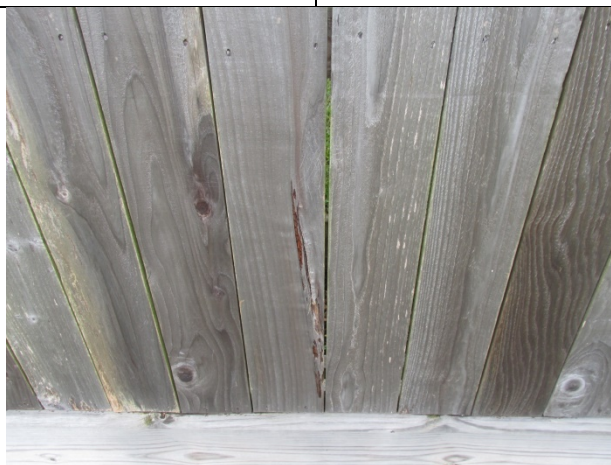
Wood rot at Miller Ranch Road

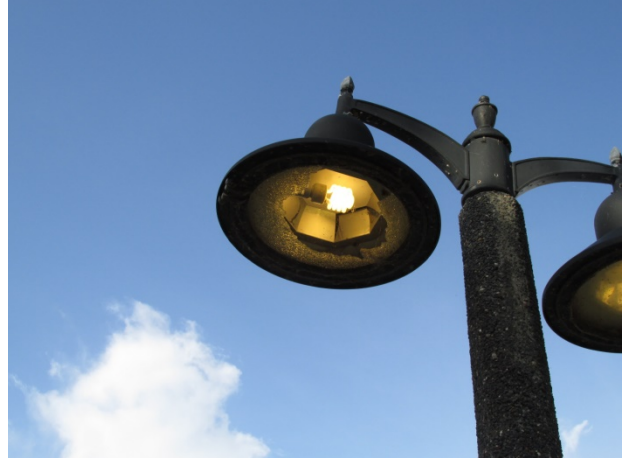
Condition: Good to fair overall

Damaged fixture

Expenditure Detail Notes: Expenditure timing and costs are depicted in the **Reserve Expenditures** table in Section 3. Management informs us the Association plans to replace the light poles and fixtures in the near term.

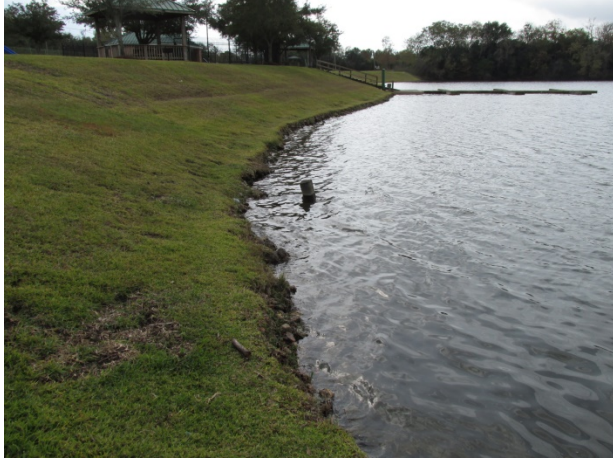
Condition: Isolated shoreline erosion evident

Minor shoreline erosion

Expenditure Detail Notes: Expenditure timing and costs are depicted in the **Reserve Expenditures** table in Section 3. We recommend the Association plan to install a combination of plantings and rip rap around the pond along 145 linear feet, or approximately twenty-five percent (25%), of the shoreline that the Association is responsible for.

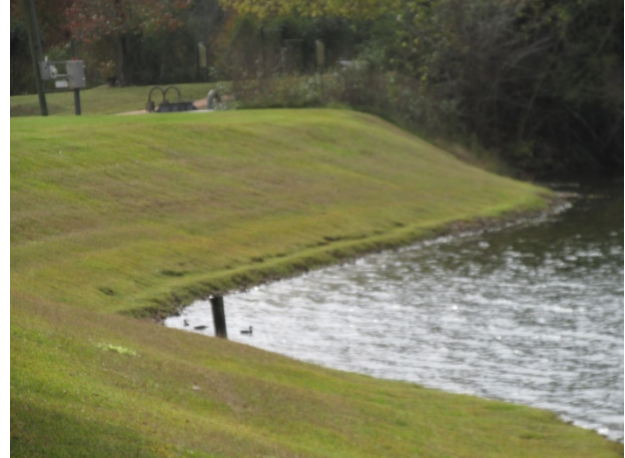
Minor erosion

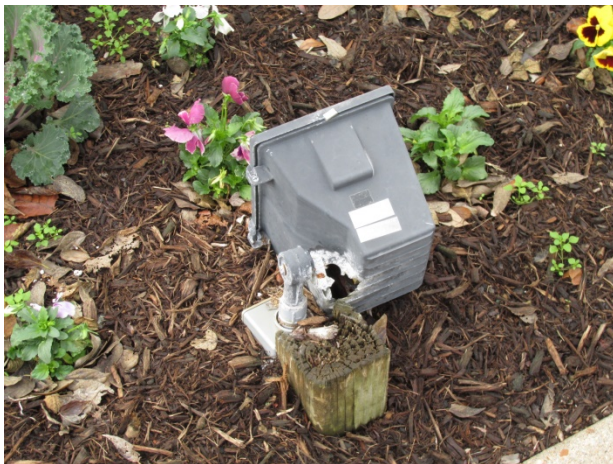
Condition: Good overall with damaged light fixtures and efflorescent evident

Damaged light fixture

Expenditure Detail Notes: Expenditure timing and costs are depicted in the **Reserve Expenditures** table in Section 3. Our cost for renovation includes repointing and repairs to the masonry and replacement of the remaining components.

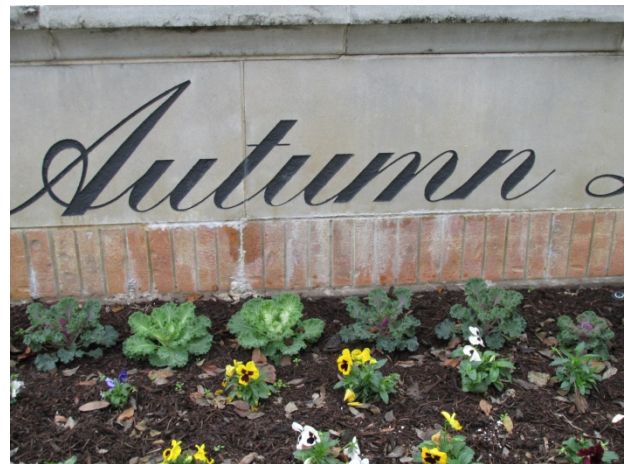
Efflorescence

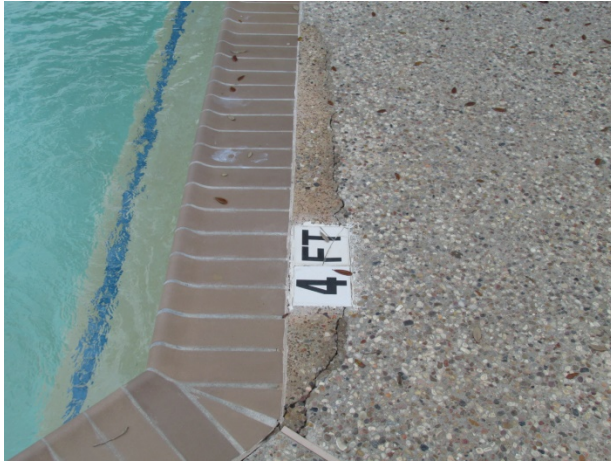
Condition: Good to fair overall with cracks and sealant deterioration evident.

Concrete deck cracks

Component Detail Notes: We recommend the Association budget for the following:

- Selective cut out and replacements of up to ten percent (10%) of concrete
- Crack repairs as needed
- Mortar joint repairs
- Caulk replacement

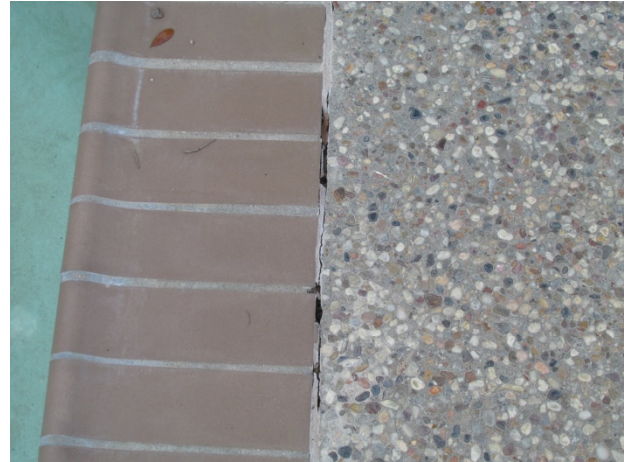
Sealant deterioration between pool coping and deck

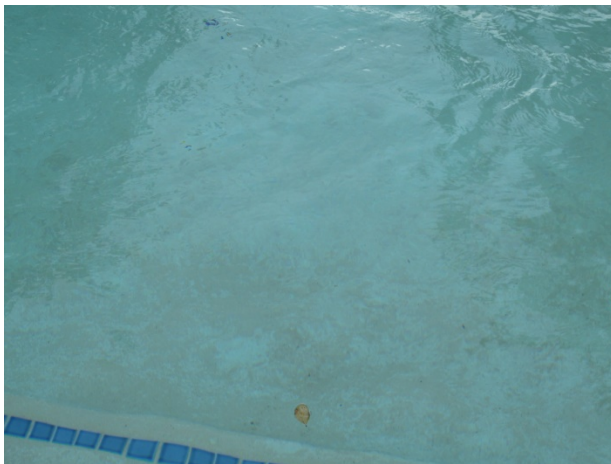
Condition: Good overall with plaster finish deterioration and efflorescence on tiles evident

Plaster finish deterioration

Component Detail Notes: Removal and replacement provides the opportunity to inspect the pool structures and to allow for partial repairs of the underlying concrete surfaces as needed. To maintain the integrity of the pool structures, we recommend the Association budget for the following:

- Removal and replacement of the plaster finishes
- Partial replacements of the scuppers and coping as needed
- Replacement of tiles as needed
- Replacement of joint sealants as needed
- Concrete structure repairs as needed

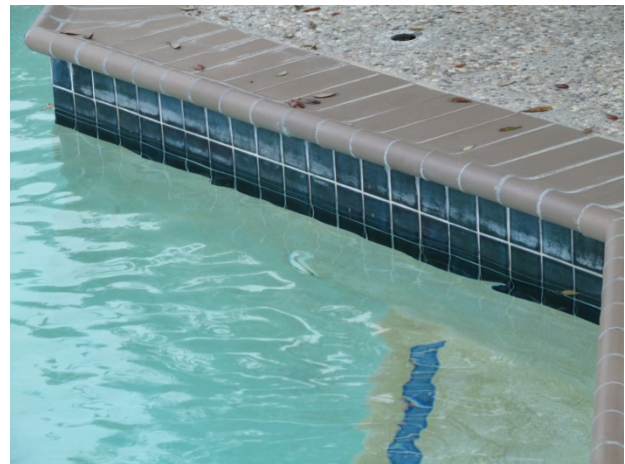
Efflorescence
